Manhole Inspection Summary

Manhole # S37M__009MH

Insp Date: **10/14/08 11:18 AM**

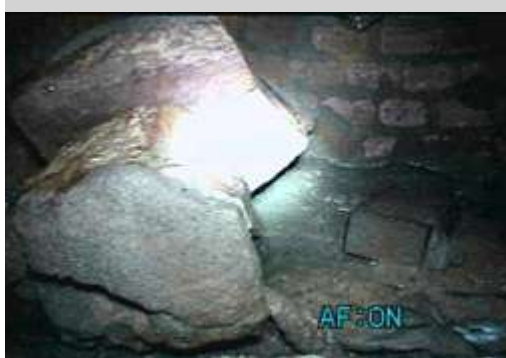
Defect 2

Condition: ☐ Sound ☐ Cracked ☐ Root Intrusion ☐ Deteriorated ☐ Leaks ☒ **Debris**

bench debris

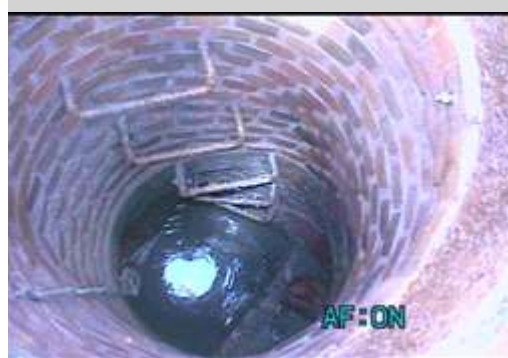
Defect 1

Steps Count: **5** Missing: **0** ☒ **Corroded**

cor. steps

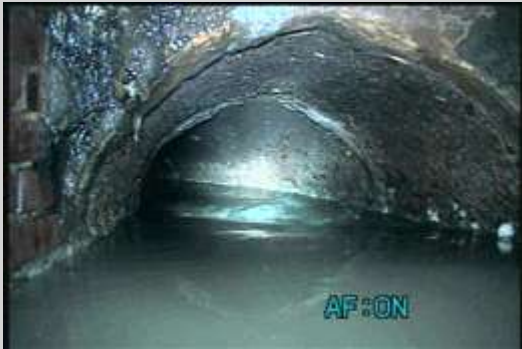
12 O'Clock Outflow

30 in. Circular Gravity Sewer
Pipe Out @ 12 O'Clock

Pipe Material: **Clay** ☐ Pipe Lined

Invert Depth: **13.20** (ft.) Flow Characteristics: **Fast**

Deposits: ☒ None ☐ Mud ☐ Sludge ☐ Debris ☐ Grease

Infiltration: **None** Pipe Seal Cond: **Unknown**

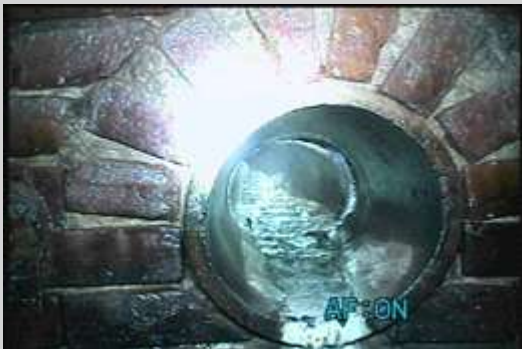
3 O'Clock Inflow

8 in. Circular Gravity Sewer
Pipe In @ 3 O'Clock

Pipe Material: **Clay** ☐ Pipe Lined

Invert Depth: **12.10** (ft.) Flow Characteristics: **Fast**

Deposits: ☒ None ☐ Mud ☐ Sludge ☐ Debris ☐ Grease

Infiltration: **None** Pipe Seal Cond: **Unknown**

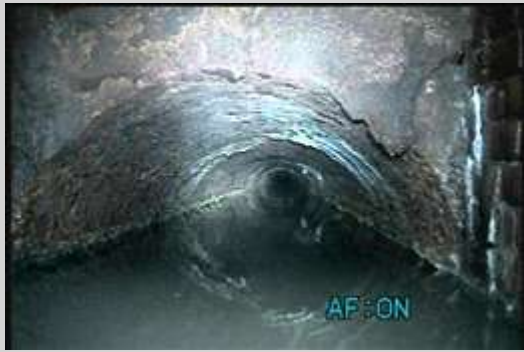
6 O'Clock Inflow

30 in. Circular Gravity Sewer

Pipe In @ 6 O'Clock

Pipe Material: **Clay** ☐ Pipe Lined

Invert Depth: **13.10** (ft.) Flow Characteristics: **Fast**

Deposits: ☒ None ☐ Mud ☐ Sludge ☐ Debris ☐ Grease

Infiltration: **None** Pipe Seal Cond: **Unknown**
